Ford F150 SuperCrew

Replace Step 6 instructions with the following:

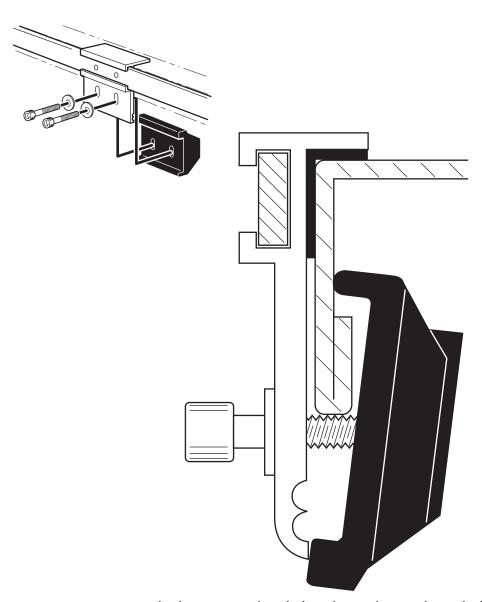
6

Attach clamp to each side bracket with two clamp bolts.

Clearance between bracket bolt and side wall rim the round bead does not fit in the bracket grooves. Invert the clamp so that the square bead contacts the lower lip of the bracket. It will rest securely on that edge.

Do not tighten at this step.
