## TRC TRI-OVAL PERFORMANCE EXHAUST

**SUZUKI**  
**2005-2006**  
**GSX-R1000**

<b>1116272</b>	TRC RACE SLIP-ON SYSTEM WITH CARBON FIBER SLEEVE
<b>1116275</b>	TRC RACE SLIP-ON SYSTEM WITH STAINLESS STEEL SLEEVE
<b>1116277</b>	TRC RACE SLIP-ON SYSTEM WITH TITANIUM SLEEVE

VOLUNTARY SAFETY RECALL CAMPAIGN #2A08  
2005 AND 2006 GSX-R1000 MOTORCYCLES  
FRAME REINFORCEMENT BRACE INSTALLATION/FRAME REPLACEMENT  
PLEASE READ IMMEDIATELY

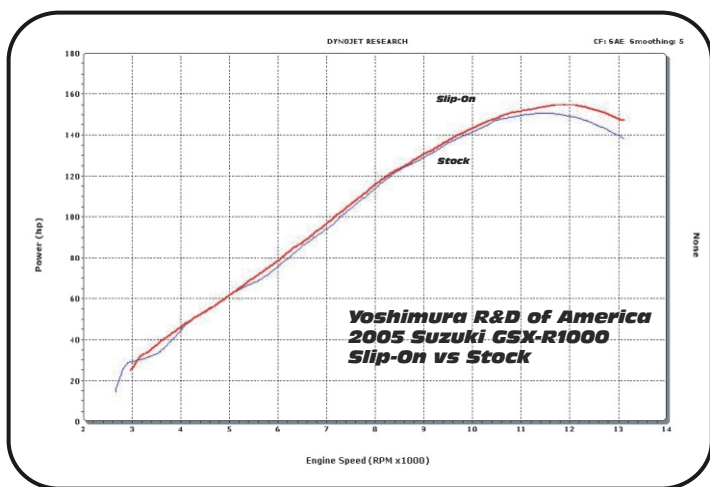
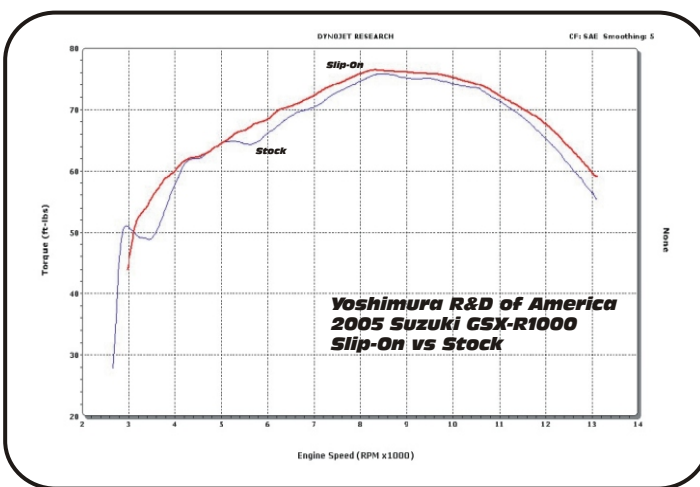
Note: Dyno graphs are for comparison use only. Actual results may vary depending on operating and motorcycle condition.

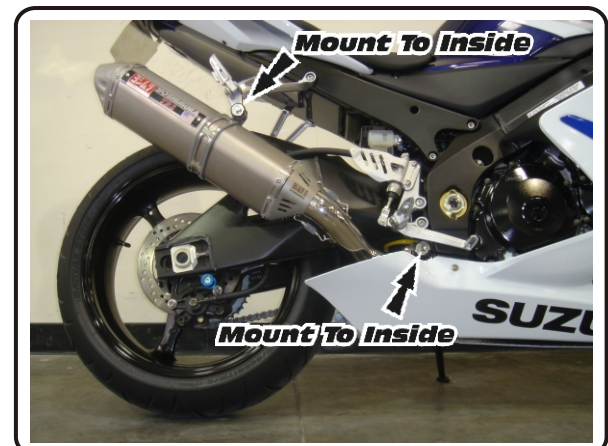
- 4 Slip supplied collector clamp over inlet of Yoshimura tail-pipe, then slip tail-pipe inlet over stock collector outlet.
- 5 Line up chassis mount on Yoshimura tailpipe with stock chassis mount location. Mount tail-pipe to inside of chassis mount using stock bolt and washer and supplied nut and washer. (See Fig.3)

- 8 Mount clamp to inside of stock muffler bracket using stock bolt, washer, and nut. (see Fig. 3 and 4)
- 9 Torque muffler clamp bolt to 2.3 kg-m (16 lb-ft)

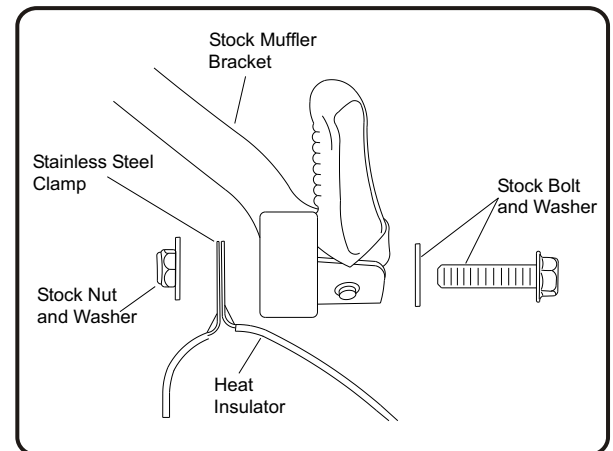
**Fig. 4**

- 6 Torque chasis mount bolt to 2.5 kg-m (16 lb-ft).
- 7 Apply heat insulator to inside of muffler clamp and slide clamp onto muffler. (note direction of clamp in Fig. 4)
